AIR QUALITY SURVEY
MERCURY CONCENTRATIONS
ON AND AROUND THE FORMER
DOMINION BRIDGE SITE
SAULT STE. MARIE
AUGUST, 1986

ARB-051-87

NOVEMBER 1987

Ministry of the Environment
Ontario

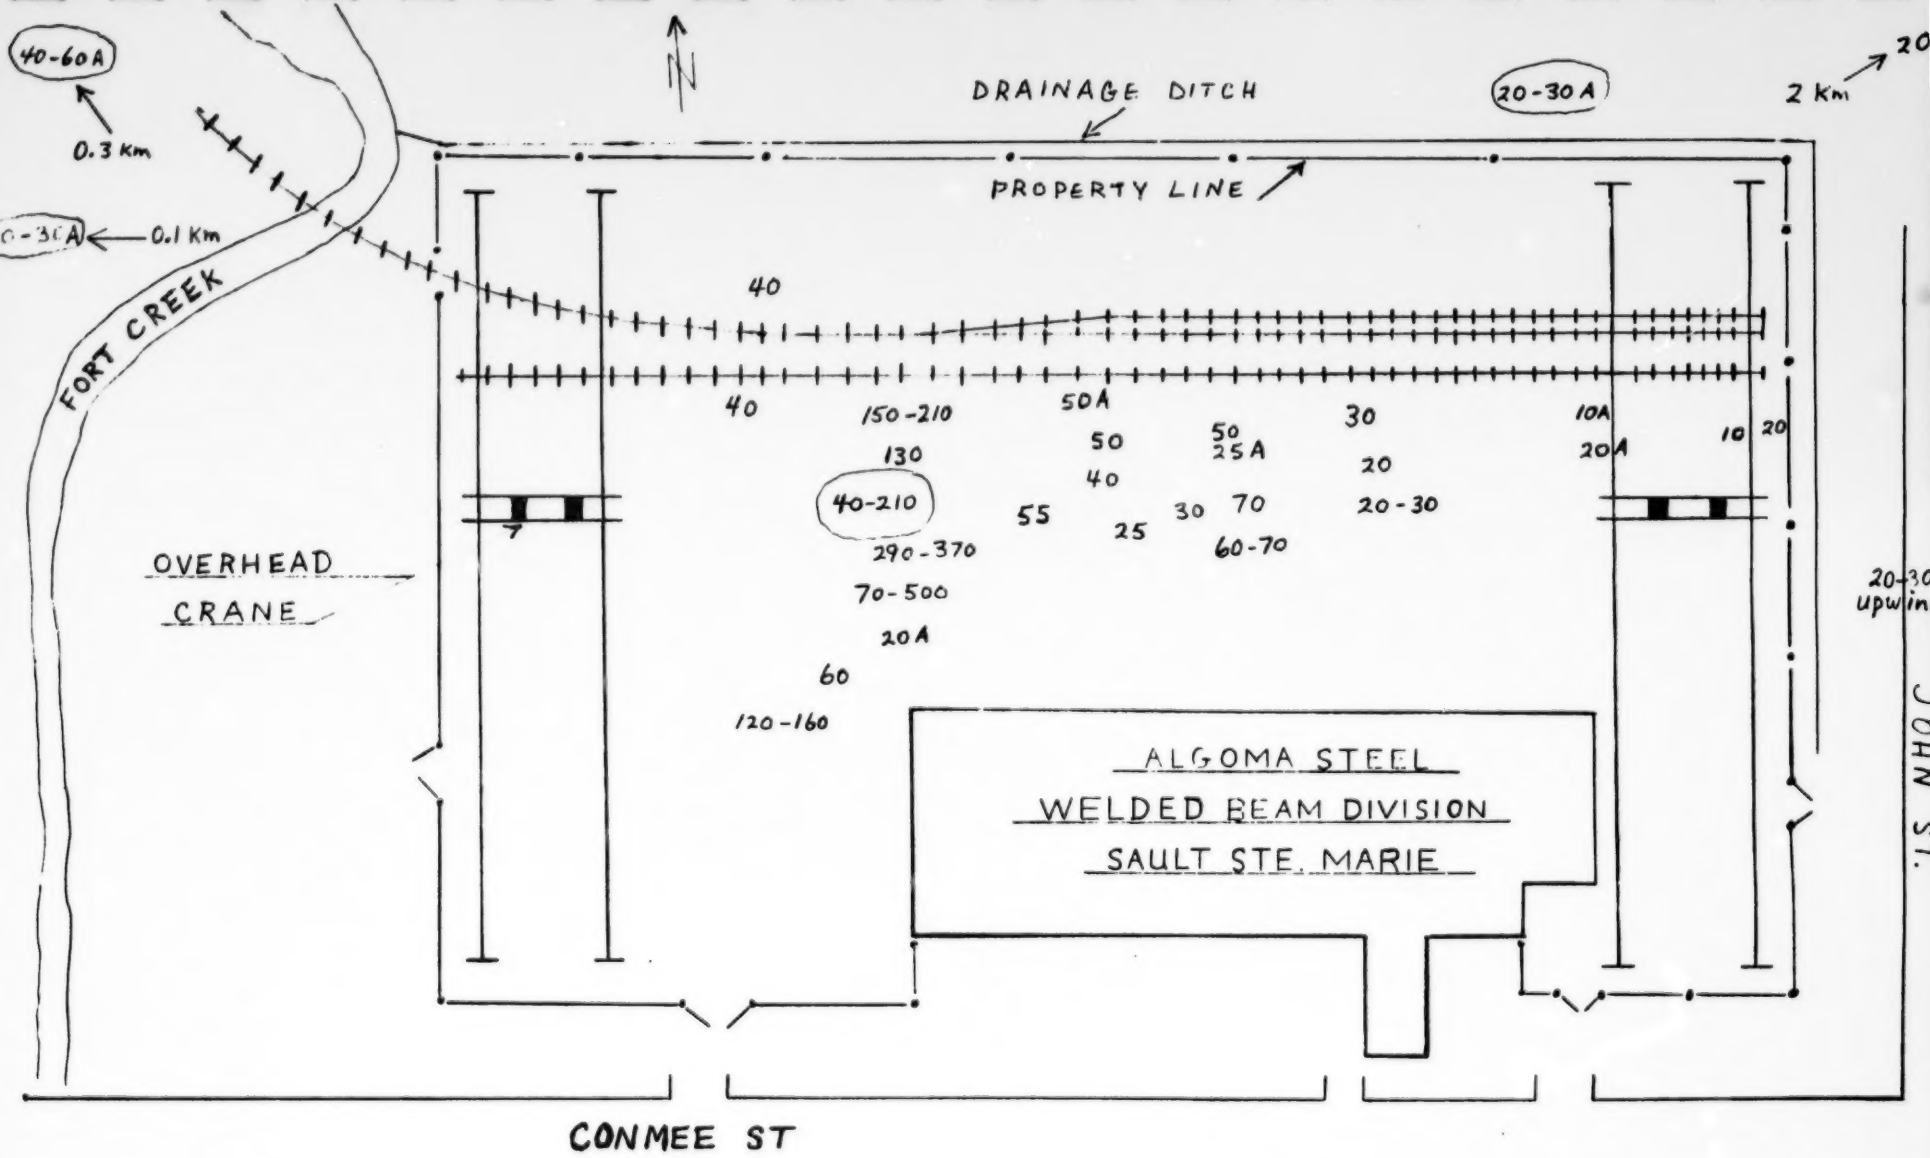
The August 20 results are more interesting because of the definite mercury presence in the soil on the plant property. The largest concentrations at the ground level were approximately 500 ng/m^3 and the smallest concentrations were around 10 ng/m^3. The largest amounts were found in the area north of the northwest corner of the main building on the site. A spatial distribution pattern for the results on the Algoma Steel property shows good agreement with the mercury isopleths contained in the soils study by the Northeastern Region.

The Hg concentrations on the site at 2-3 meters height were always in the range of 10 to 50 ng/m^3.

Figure 1. Mercury (Hg) concentrations, nanograms per metre cubed (ng/m^3).
